UNITED STATES ENVIRONMENTAL PROTECTION AGENCY

SUBJECT: Inspection Report Transmittal to Ledgeview Farms, LLC

On April 9, 2015, EPA conducted an inspection of your facility, Ledgeview Farms in De Pere, Wisconsin. The purpose of the inspection was to evaluate compliance with the Clean Water Act (CWA) and Administrative Order V-W-13-AO-22. Ledgeview Farms is a large Concentrated Animal Feeding Operation (CAFO) as defined in 40 C.F.R. § 122. During the inspection, we observed violations of the CWA and Administrative Order. The CWA and Order requires you to immediately cease all unauthorized discharges.

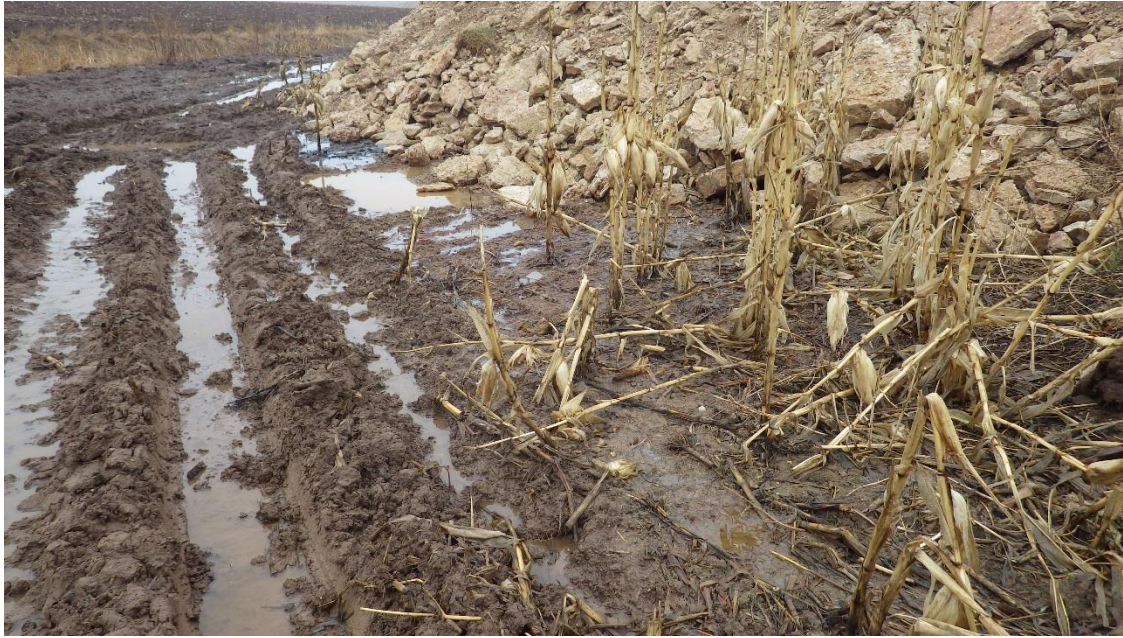
120: RIMG0129

Description: The leachate was seeping out of the rock/soil.

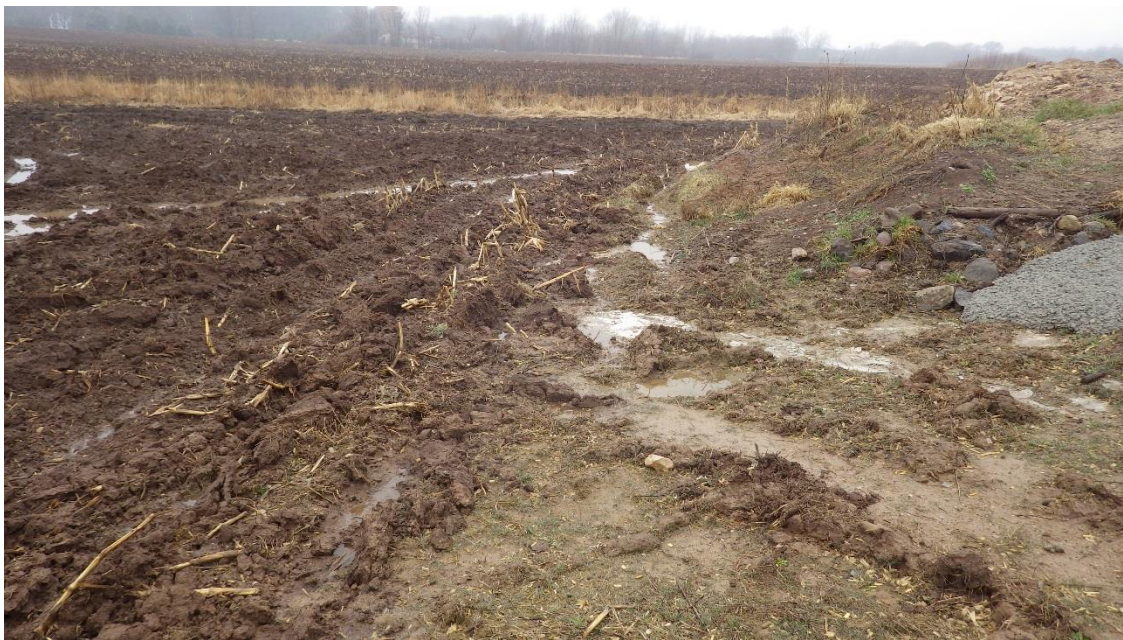
121: RIMG0130

Description: The leachate was seeping out of the rock/soil.

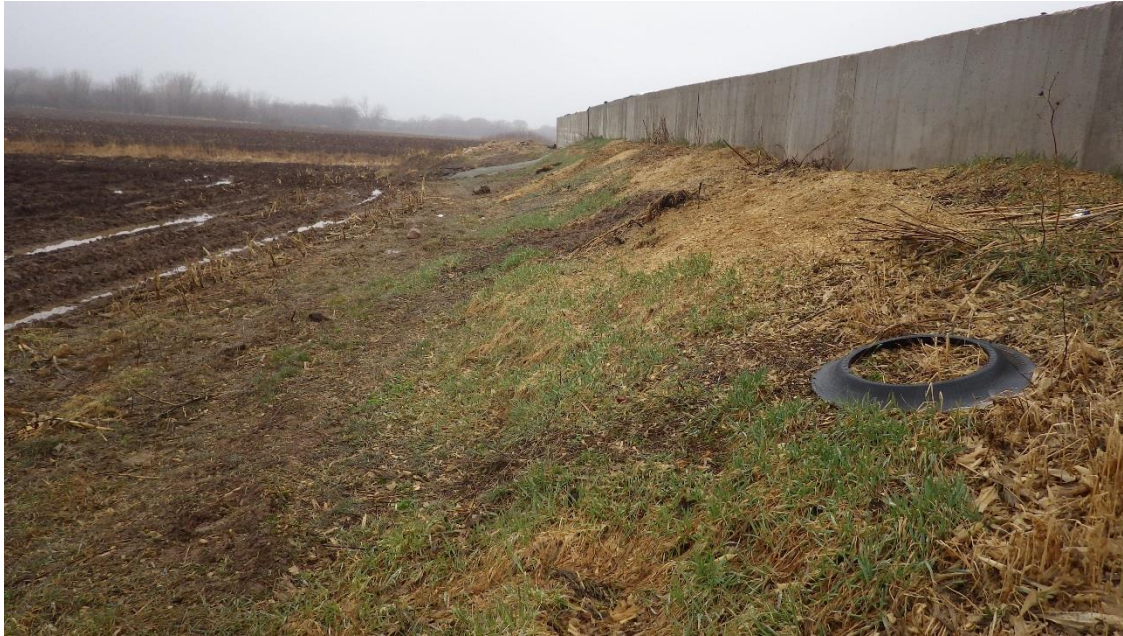
122: RIMG0131

Description: The topography on the south side of the feed bunkers are situated such that it drains to the unnamed tributary.

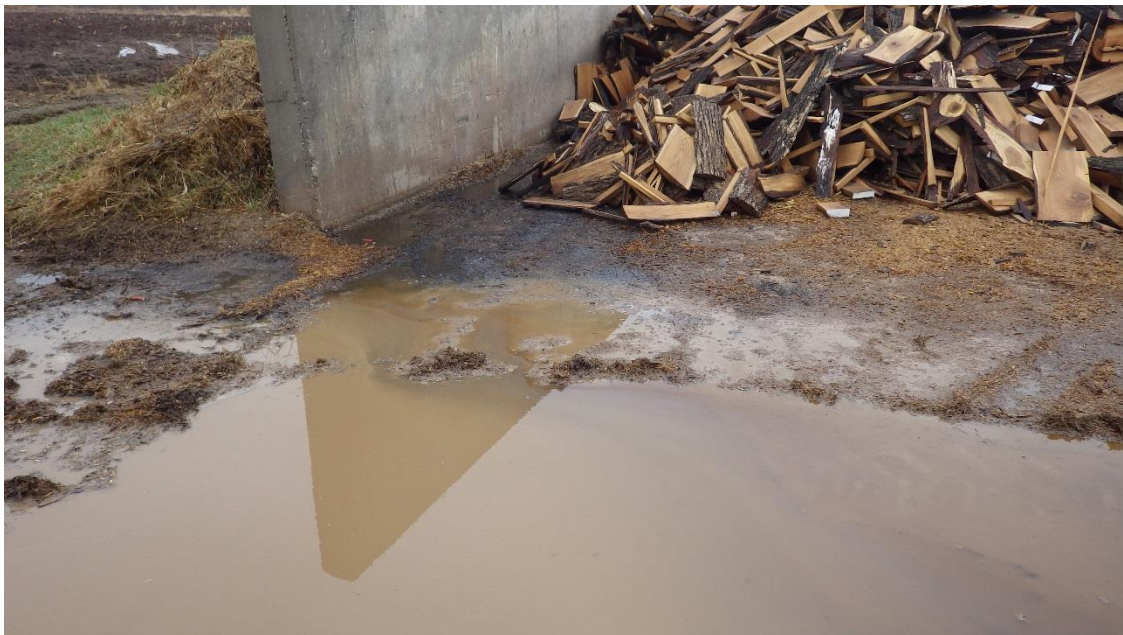
123: RIMG0132

Description: The topography on the south side of the feed bunkers are situated such that it drains to the unnamed tributary.

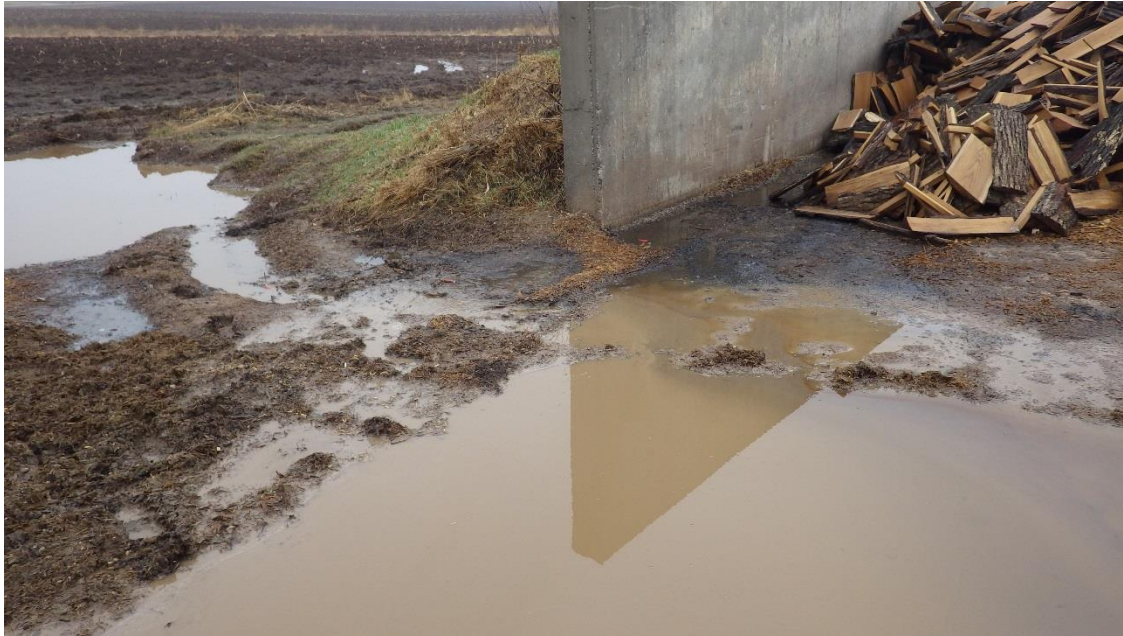
124: RIMG0133

Description: Process wastewater from the southeast end of the feed bunker flows south into the field.

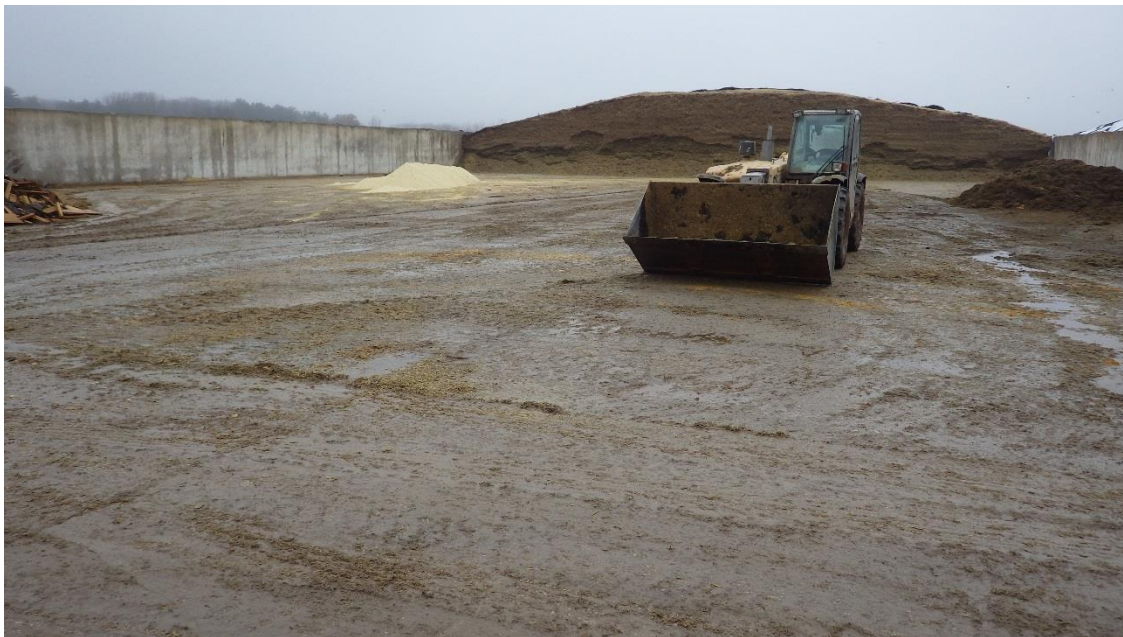
125: RIMG0134

Description: Process wastewater from the southeast end of the feed bunker flows south into the field.

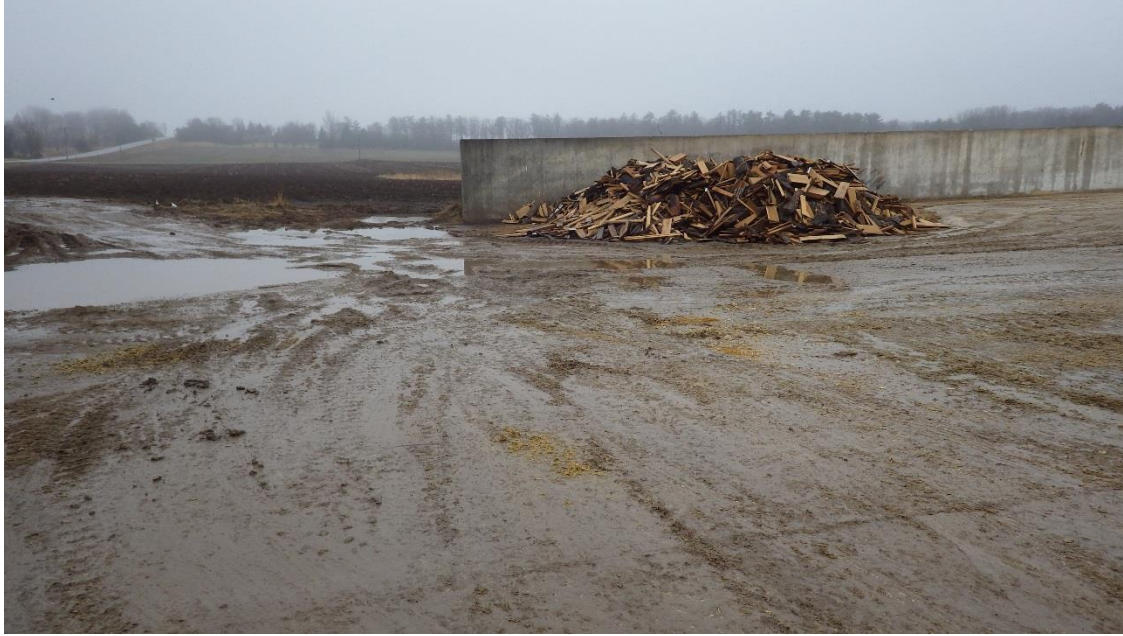
126: RIMG0135

Description: Raw material and feeds solids were scattered throughout the concrete surface of the feed bunker.

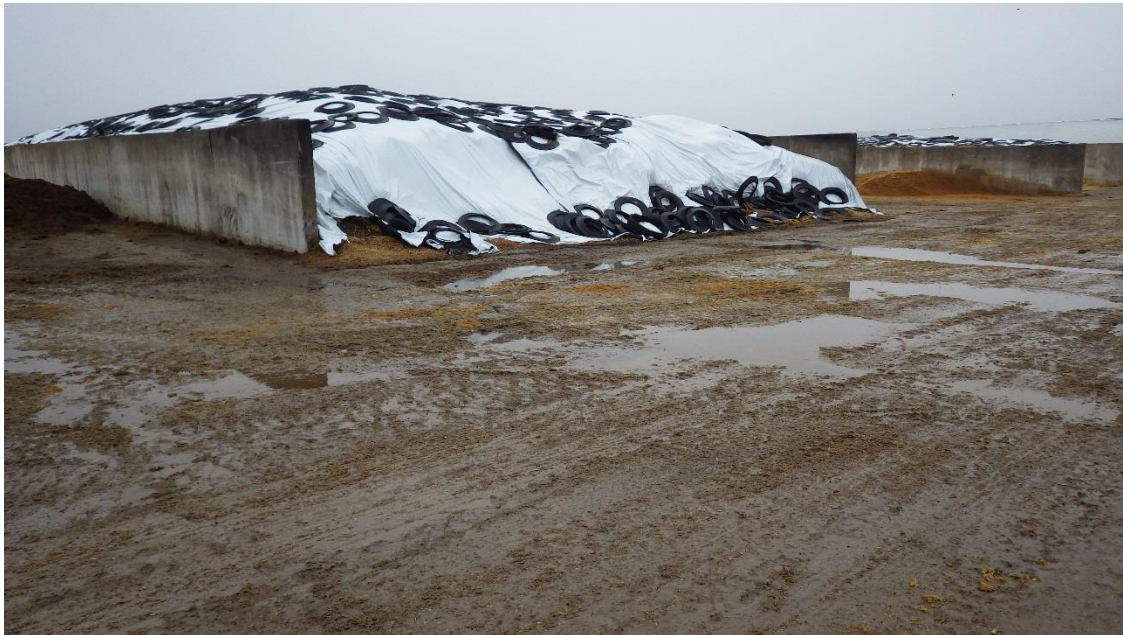
127: RIMG0136

Description: Process wastewater from the southeast end of the feed bunker flows south into the field.

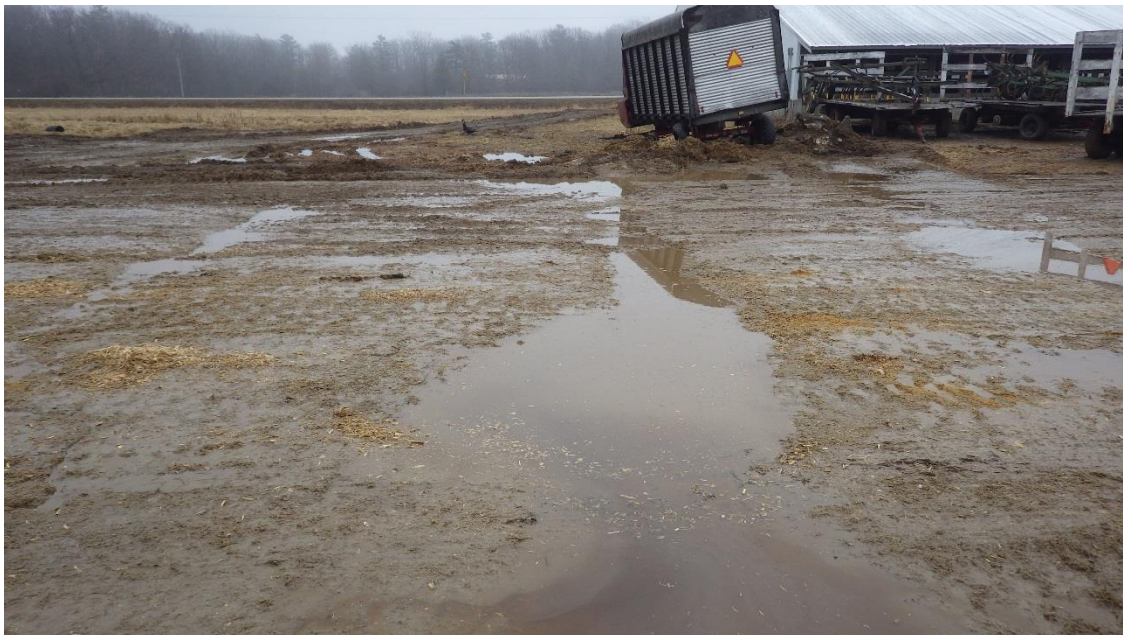
147: RIMG0156

Description: Drainage pathways from the feed bunkers flowed east to the grassed area. Process wastewater and feed solids were observed throughout the drainage pathways.

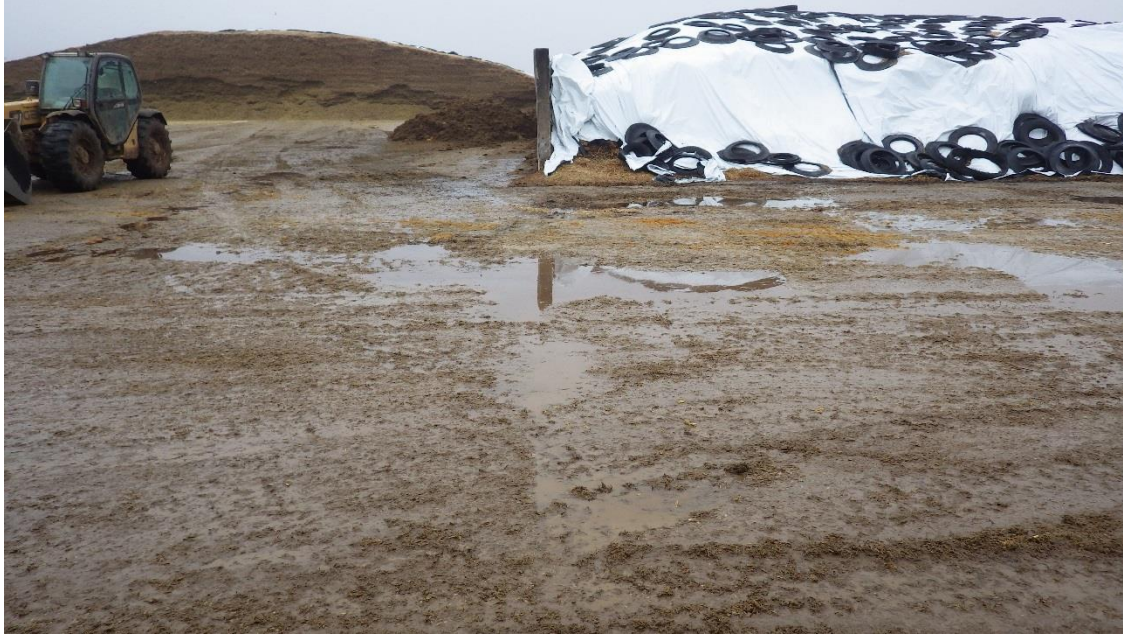
148: RIMG0157

Description: Drainage pathways from the feed bunkers flowed east to the grassed area. Process wastewater and feed solids were observed throughout the drainage pathways.

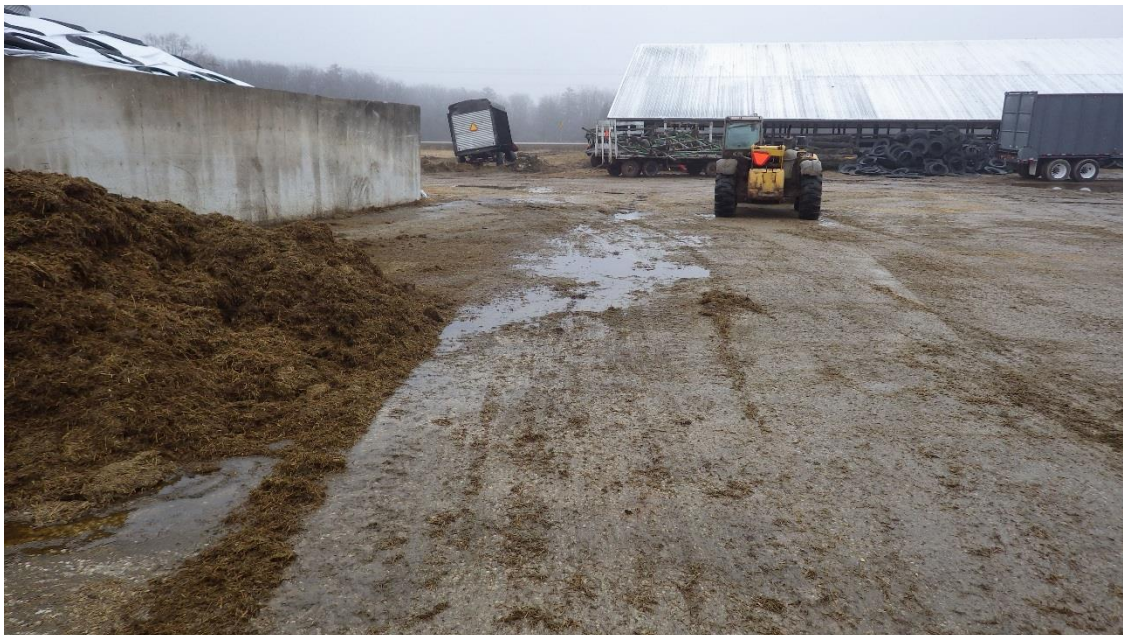
149: RIMG0158

Description: Drainage pathways from the feed bunkers flowed east to the grassed area. Process wastewater and feed solids were observed throughout the drainage pathways.

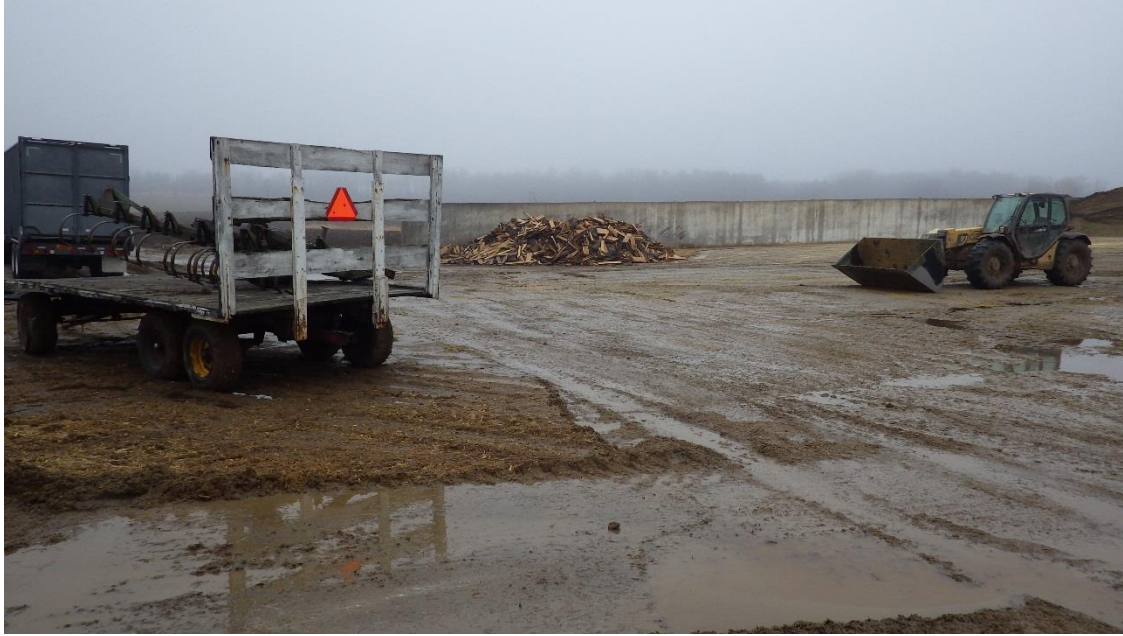
150: RIMG0159

Description: Drainage pathways from the feed bunkers flowed east to the grassed area. Process wastewater and feed solids were observed throughout the drainage pathways.

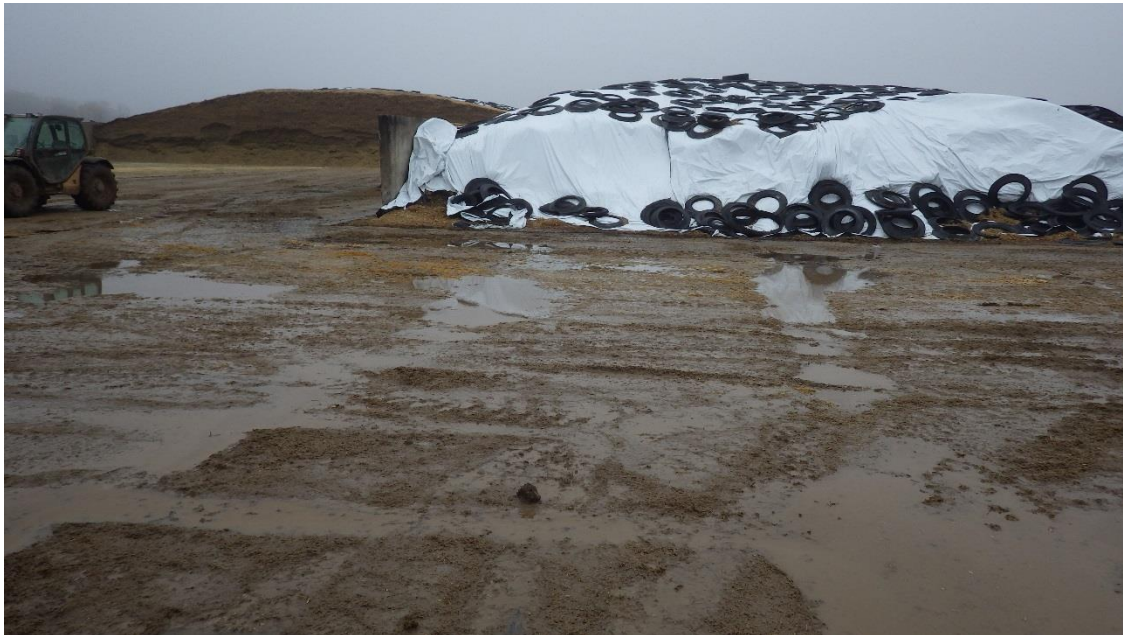
151: RIMG0160

Description: Drainage pathways from the feed bunkers flowed east to the grassed area. Process wastewater and feed solids were observed throughout the drainage pathways.

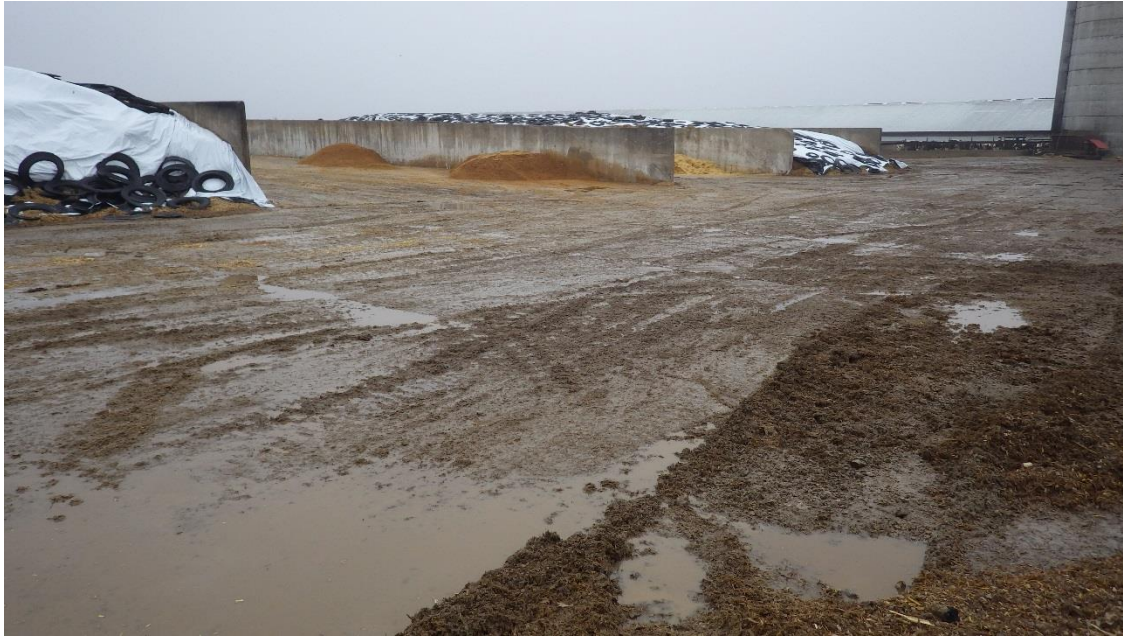
152: RIMG0161

Description: Drainage pathways from the feed bunkers flowed east to the grassed area. Process wastewater and feed solids were observed throughout the drainage pathways.

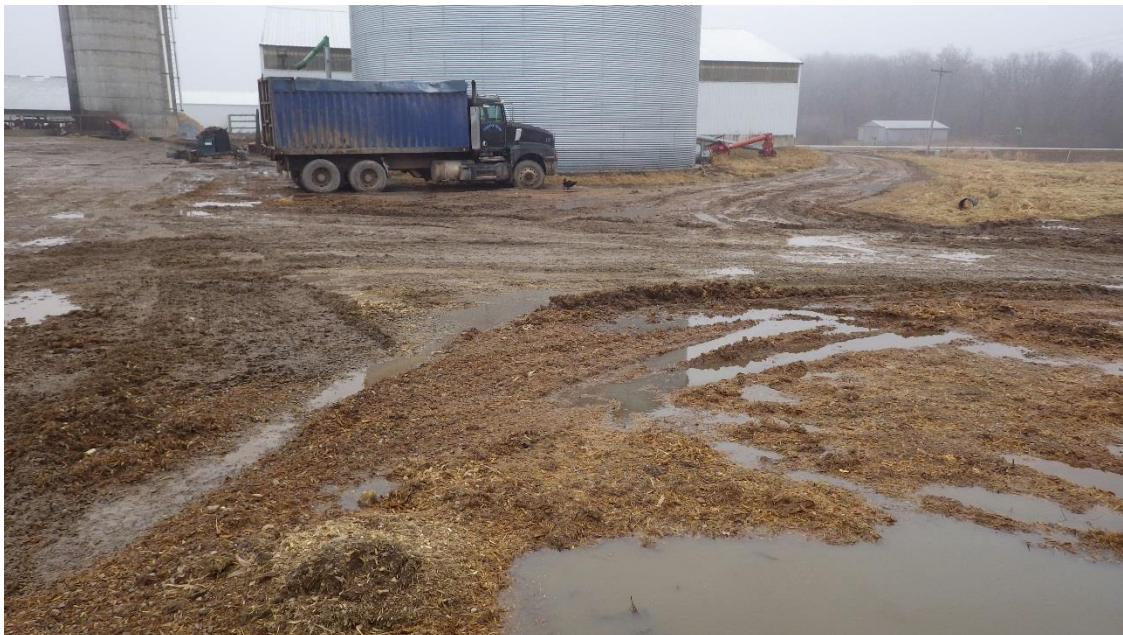
153: RIMG0162

Description: Drainage pathways from the feed bunkers flowed east to the grassed area. Process wastewater and feed solids were observed throughout the drainage pathways.

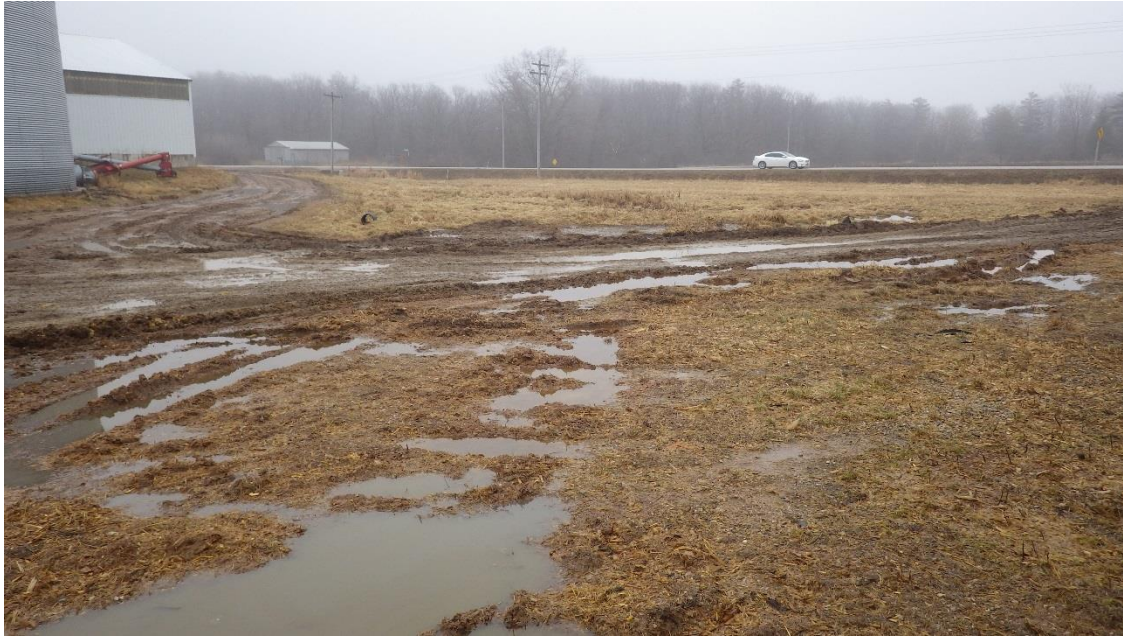
154: RIMG0163

Description: Drainage pathways from the feed bunkers flowed east to the grassed area. Process wastewater and feed solids were observed throughout the drainage pathways.

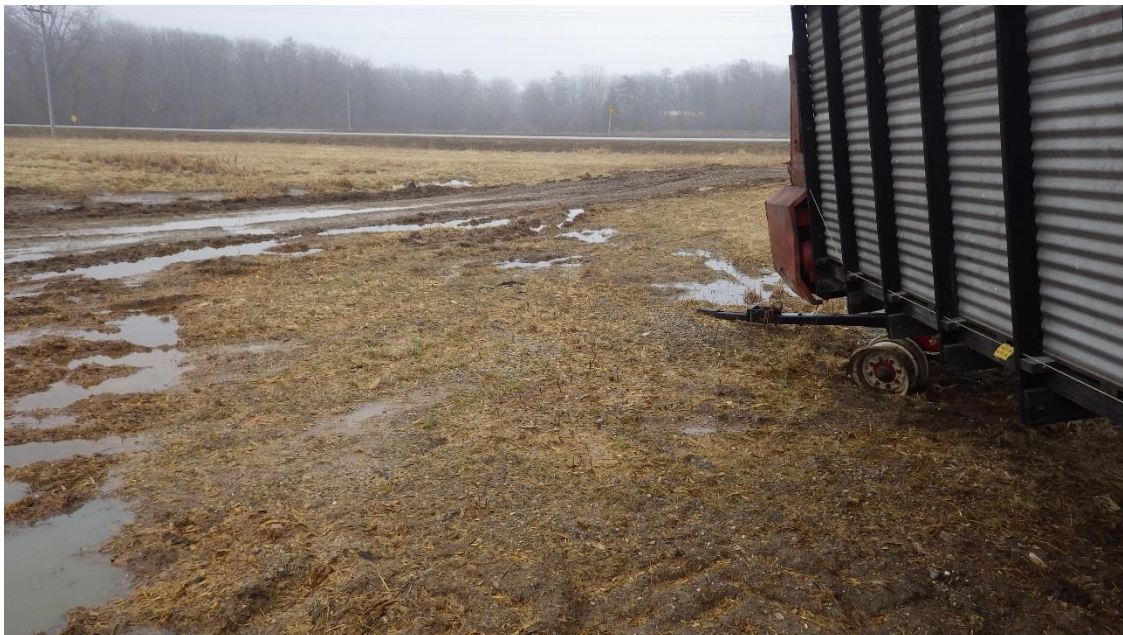
155: RIMG0164

Description: Drainage pathways from the feed bunkers flowed east to the grassed area. Process wastewater and feed solids were observed throughout the drainage pathways.

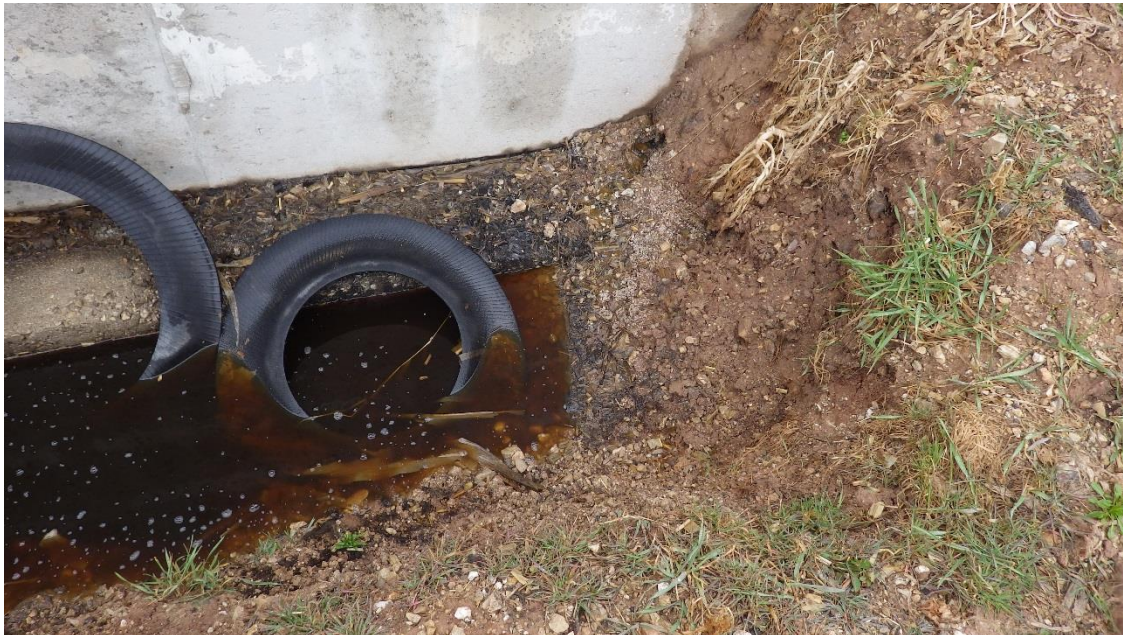
157: RIMG0166

Description: A drainage pathways from the southeast end of the feed bunkers flowed south into a field.

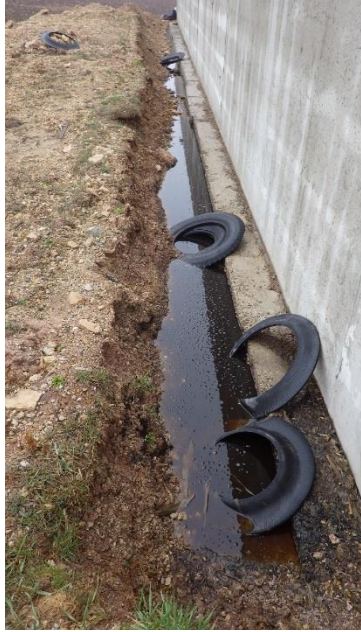
158: RIMG0167

Description: Silage leachate was observed along the south wall of the new bunker. The leachate seeped through the rock/soil and flowed overland to the unnamed tributary.

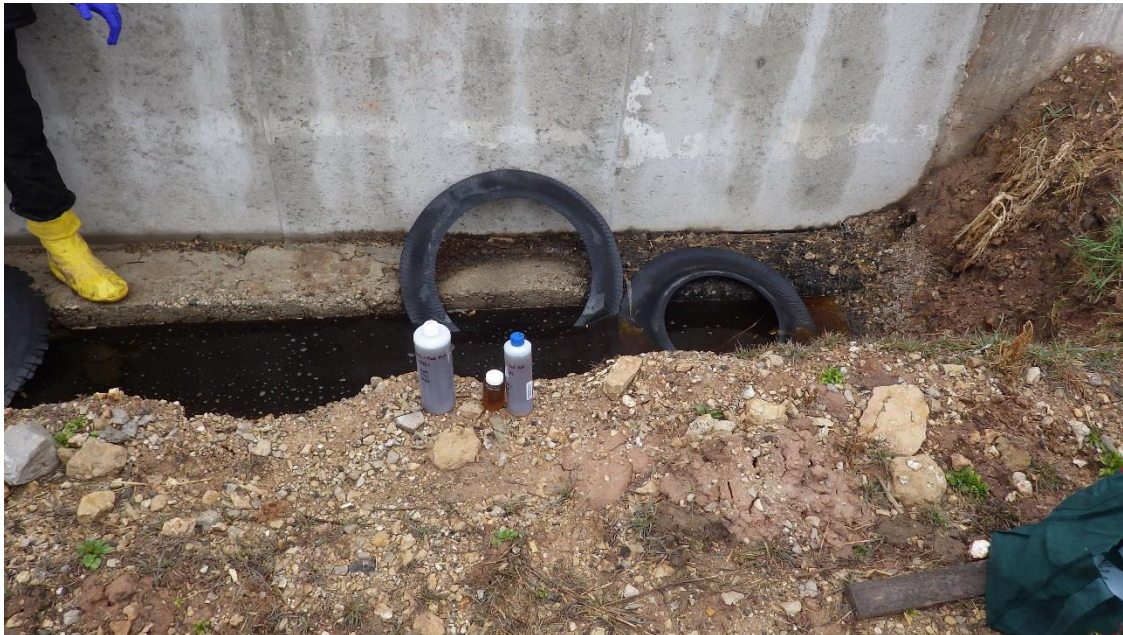
159: RIMG0168

Description: Silage leachate was observed along the south wall of the new bunker. The leachate seeped through the rock/soil and flowed overland to the unnamed tributary.

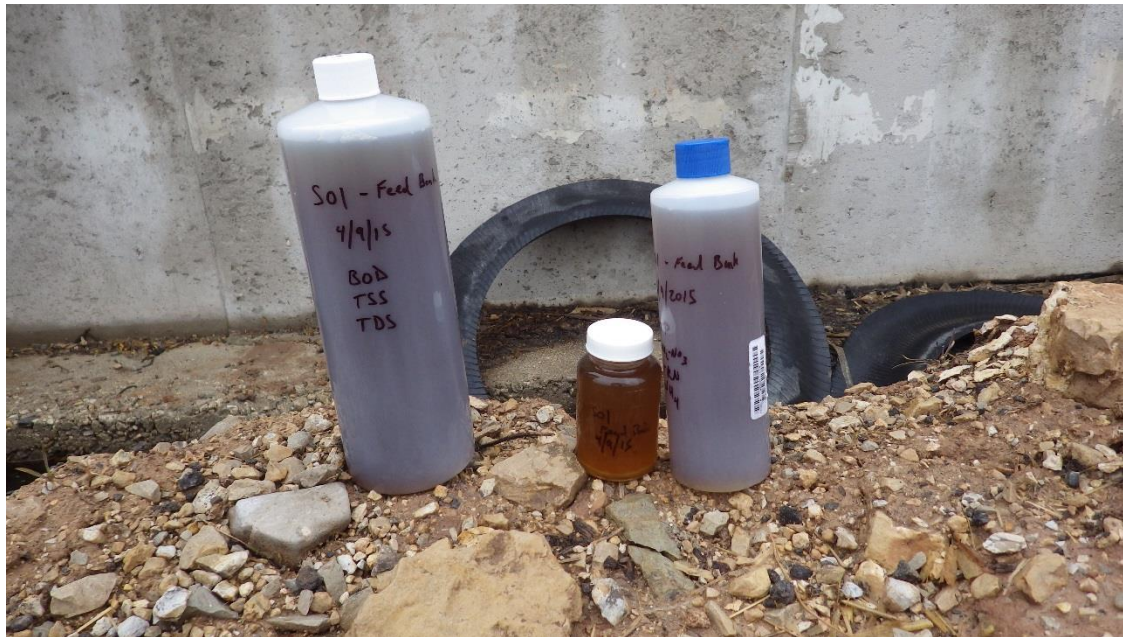
160: RIMG0169

Description: Sample S01 was taken at 11:14 a.m. of process wastewater from the new bunker.

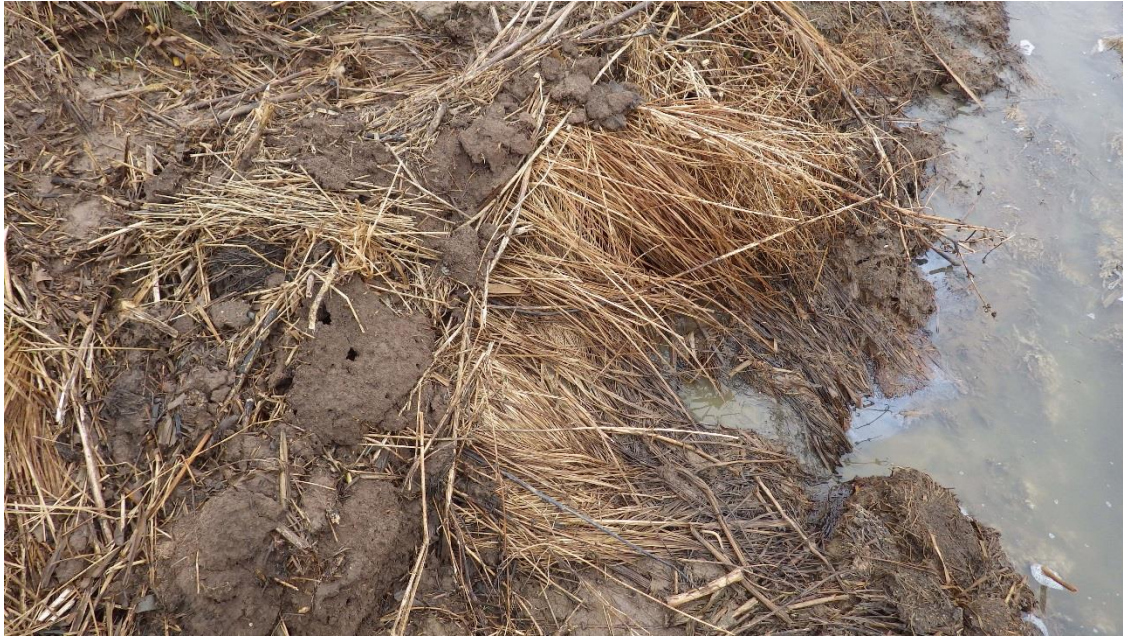
162: RIMG0171

Description: Process wastewater from the new bunker flowed into the unnamed tributary.

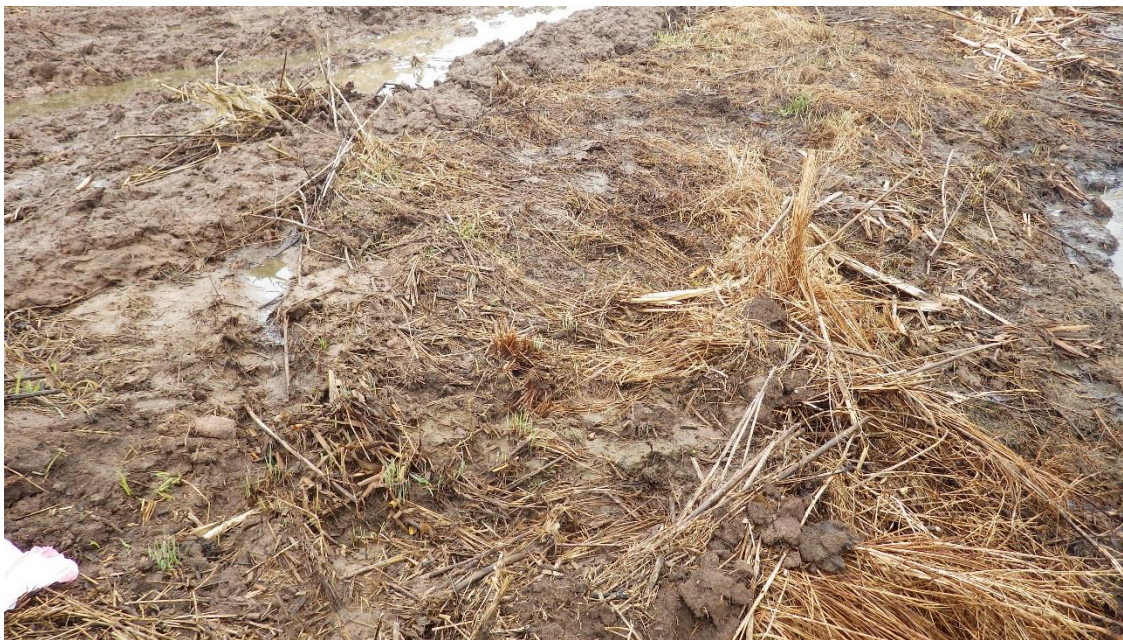
163: RIMG0172

Description: Process wastewater from the new bunker flowed into the unnamed tributary.

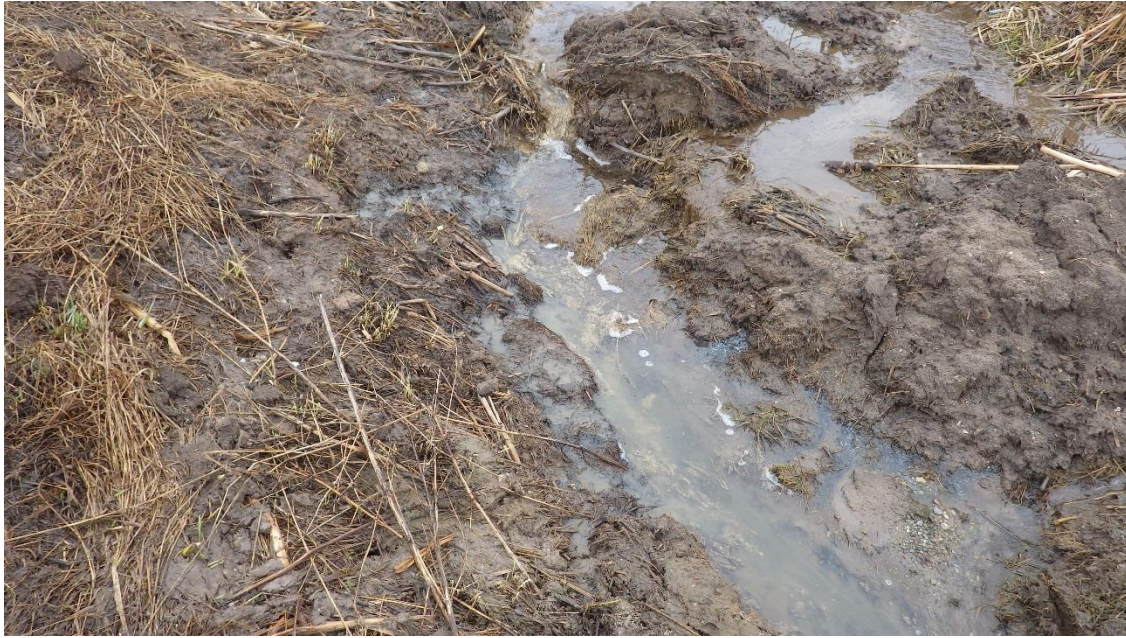
164: RIMG0173

Description: Process wastewater from the new bunker flowed into the unnamed tributary.

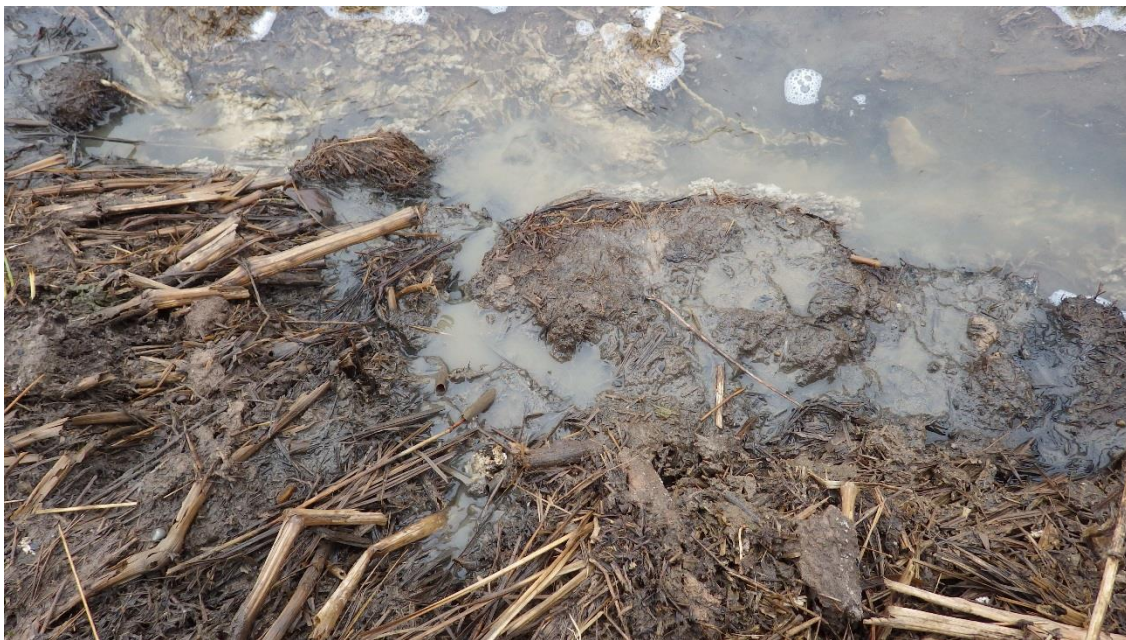
165: RIMG0174

Description: Process wastewater from the new bunker flowed into the unnamed tributary.

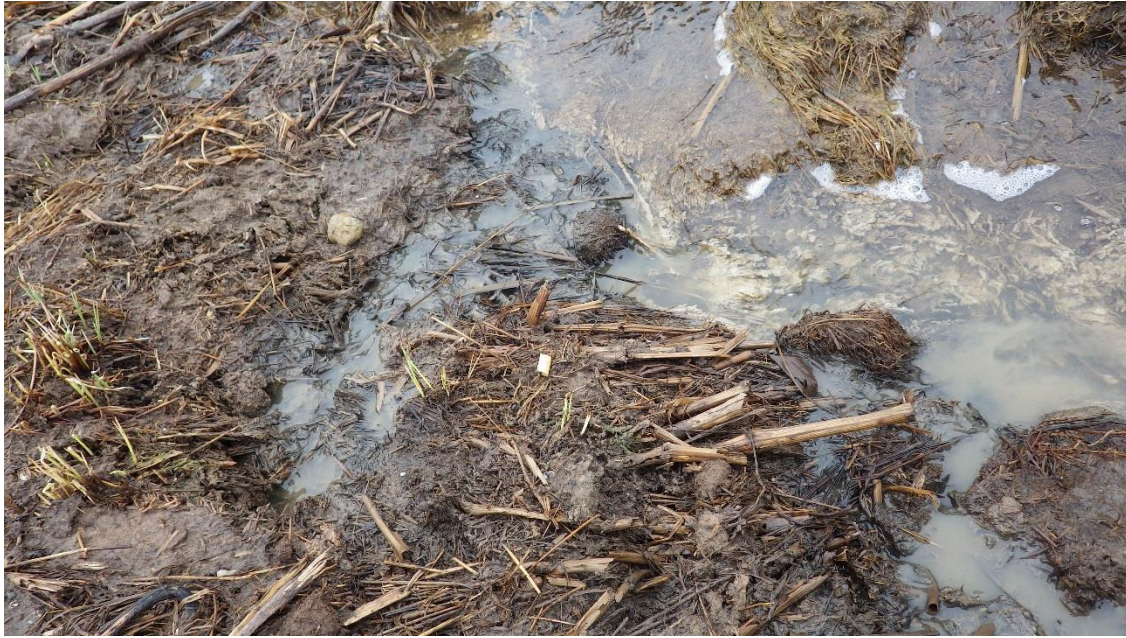
166: RIMG0175

Description: Process wastewater from the new bunker flowed into the unnamed tributary.

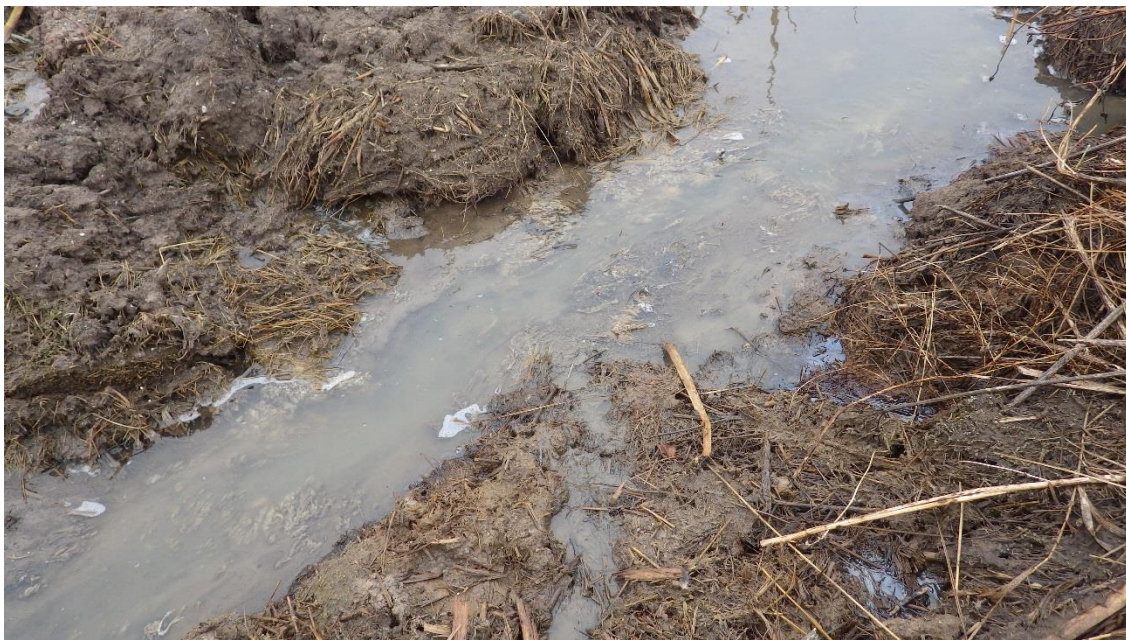
167: RIMG0176

Description: Process wastewater from the new bunker flowed into the unnamed tributary.

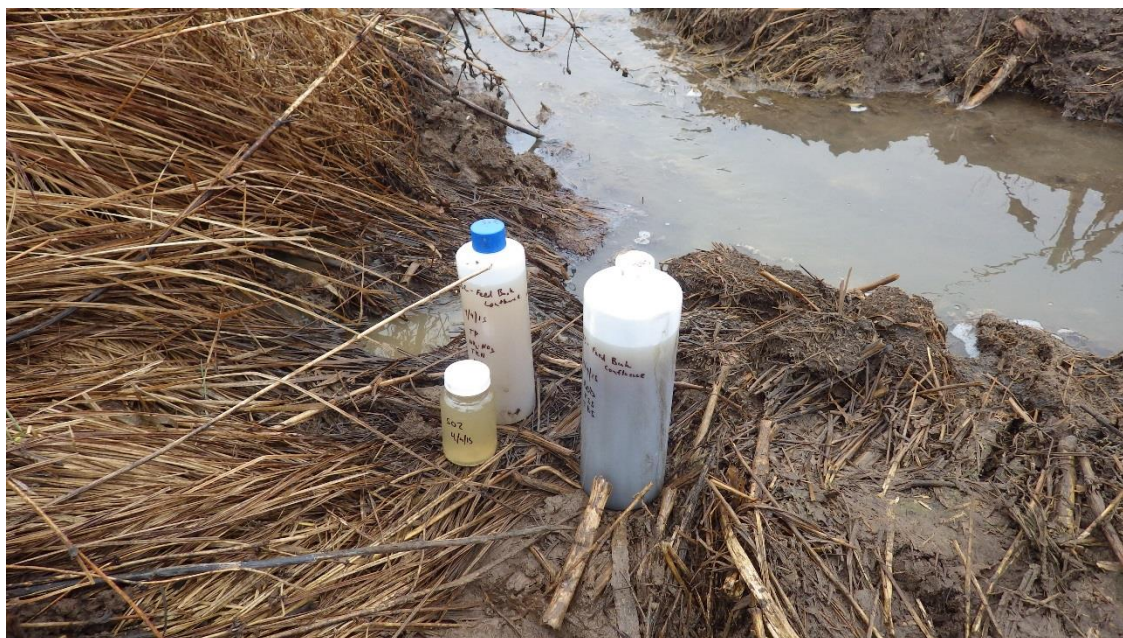
168: RIMG0177

Description: Process wastewater from the new bunker flowed into the unnamed tributary.

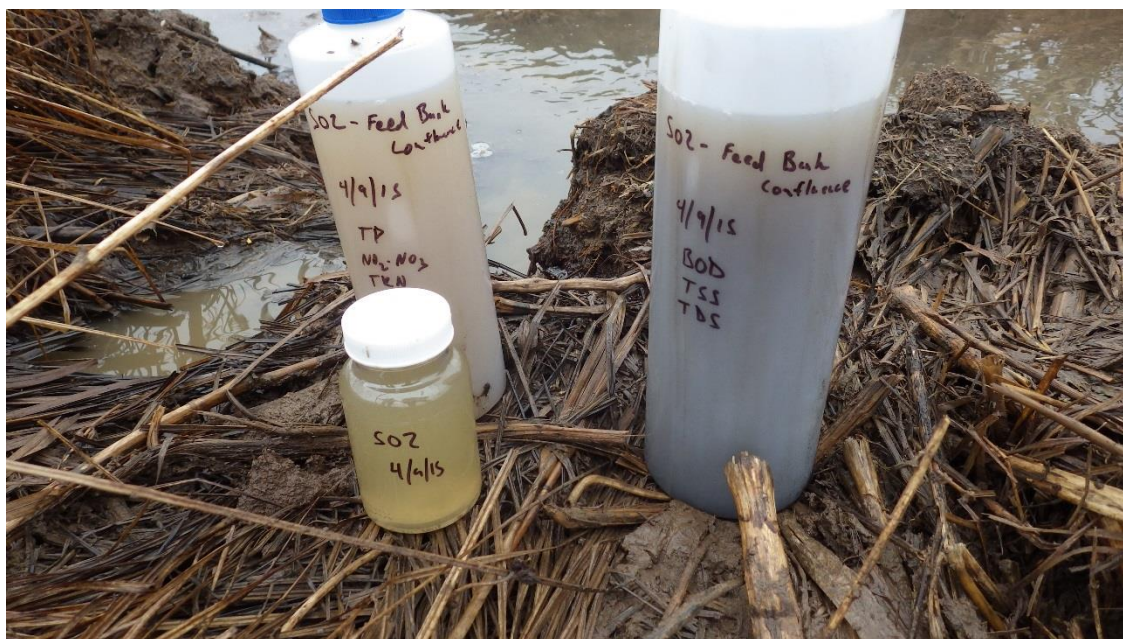
169: RIMG0178

Description: Sample S02 was taken at 11:25 a.m. of process wastewater emanating from the new bunker and flowing into an unnamed tributary.

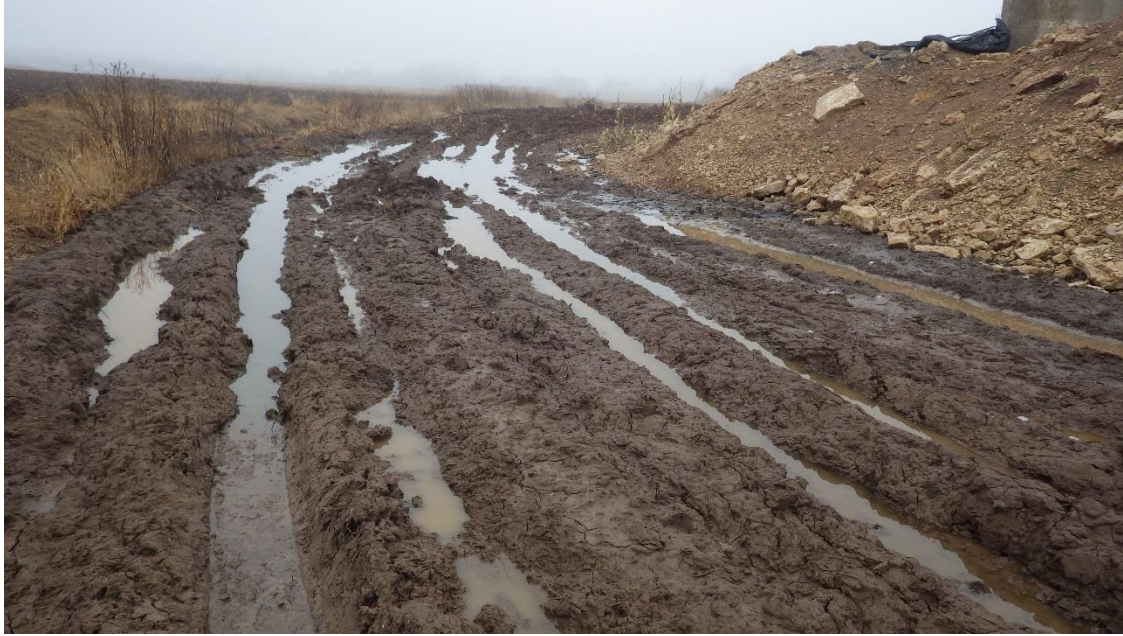
170: RIMG0179

Description: Sample S02 was taken at 11:25 a.m. of process wastewater emanating from the new bunker and flowing into an unnamed tributary.

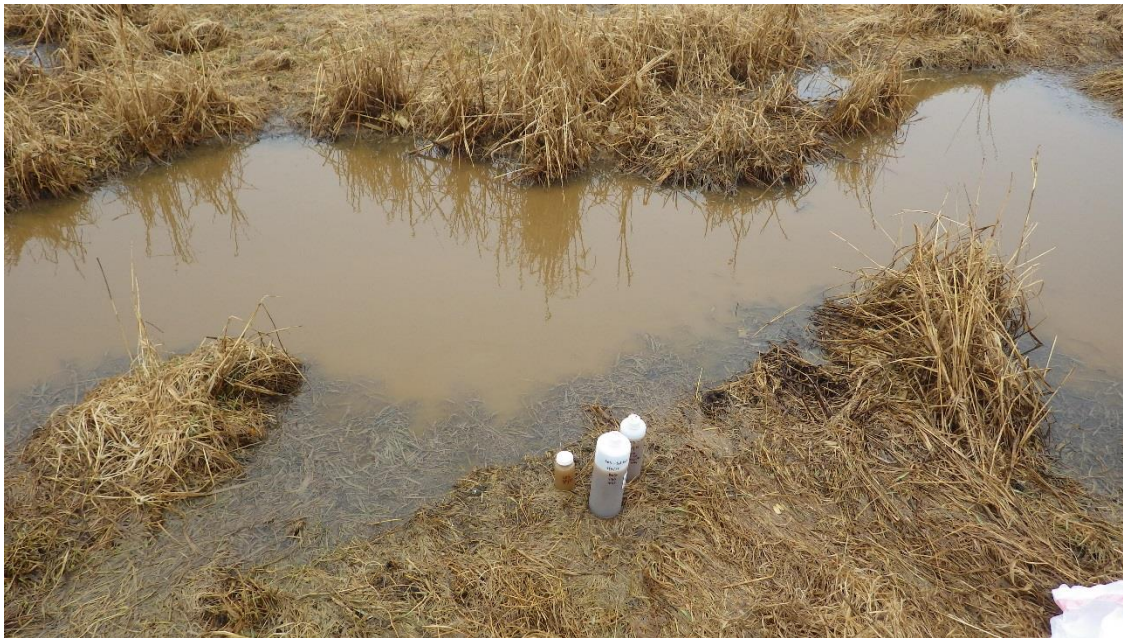
171: RIMG0180

Description: The leachate was draining west through tire ruts and into the unnamed tributary.
